**Heatherridge South**  
**Aurora, CO**

Report #: 21891-3  
Beginning: January 1, 2026  
Expires: December 31, 2026

**RESERVE STUDY**  
**Update "With-Site-Visit"**

March 21, 2025

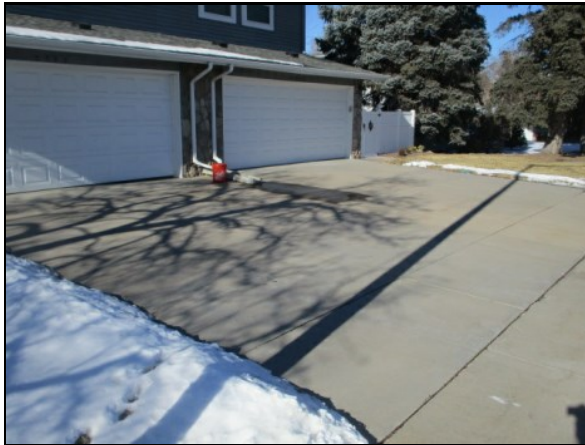
**Life:**

0 years

**Best Case:** \$ 46,000

**Worst Case:** \$ 61,000

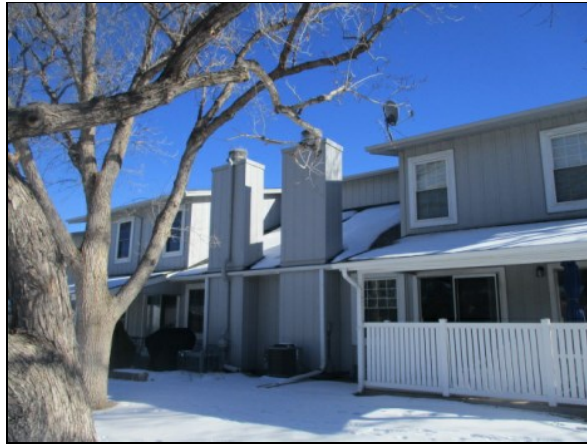
**Life:**

0 years

**Best Case:** \$ 390,000

**Worst Case:** \$ 547,000

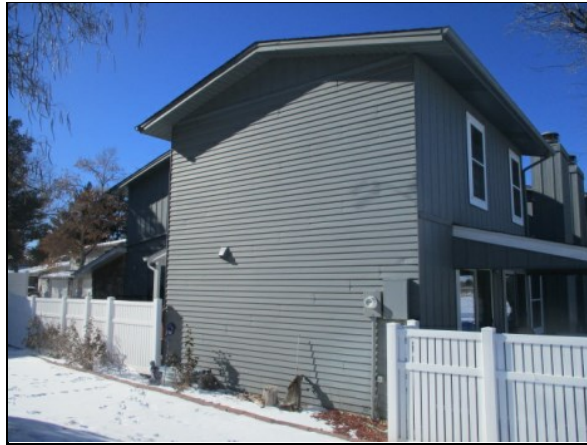
**Life:**

6 years

**Best Case:** \$ 600,000

**Worst Case:** \$ 780,000

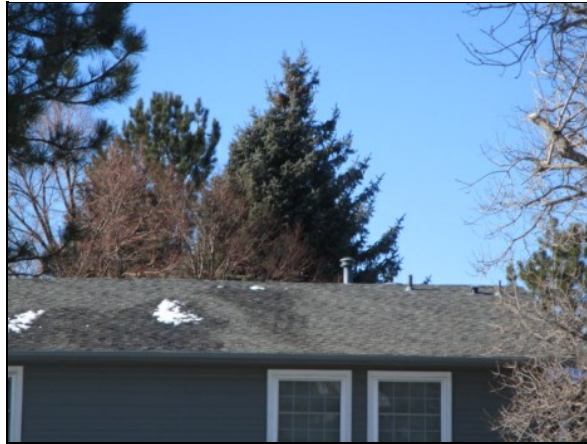
**Useful Life:**  
25 years

**Remaining Life:**  
13 years

**Best Case:** \$ 1,515,000

**Worst Case:** \$ 2,100,000

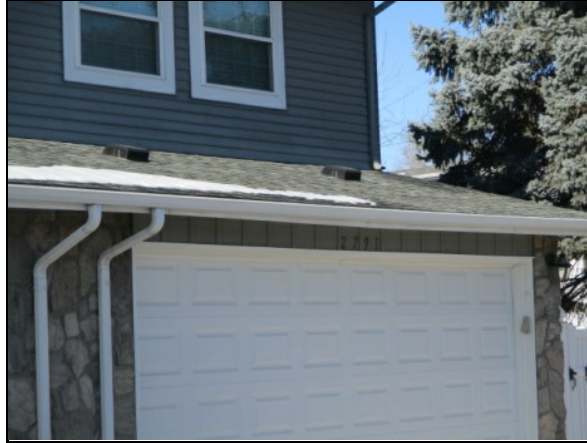
**Life:**

13 years

**Best Case:** \$ 92,000

**Worst Case:** \$ 116,000

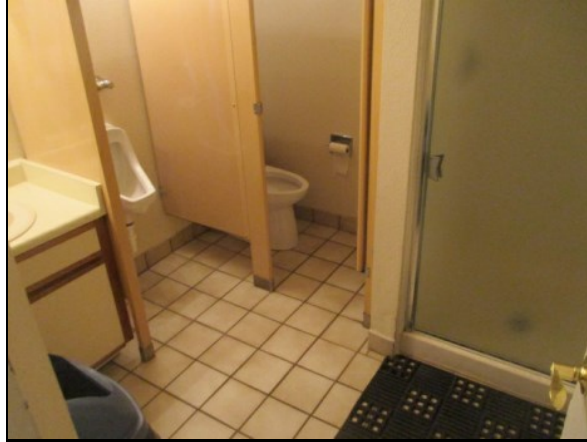
**Comments:** Bathrooms were determined to be in fair condition. Flooring did not exhibit any un-even or broken sections. Fixtures appeared to be in slightly outdated condition, but no major issues observed. As routine maintenance, inspect regularly and perform any needed repairs promptly utilizing general Operating funds. Typical remodeling project can include some or all of the following replacement of plumbing fixtures, partitions, countertops, lighting, flooring, ventilation fans, accessories, decor, etc. Best practice is to coordinate this type of project with other areas whenever possible. Schedule and cost estimates should be re-evaluated during future Reserve Study updates and adjusted as needed based on the client's good judgment.

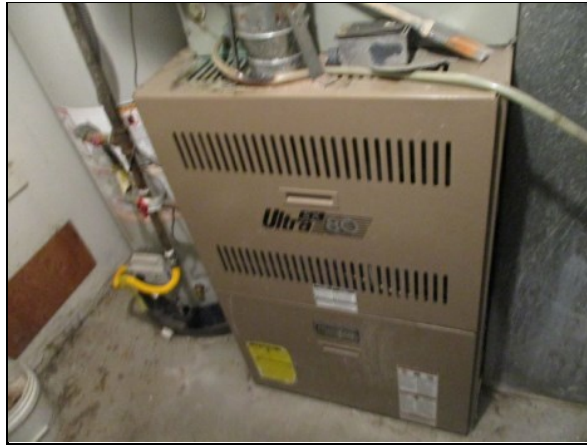
**Comp #: 25180 Furnace - Replace (Armstrong)**

**Comments:** Armstrong Ultra SX 80 150k BTU model GUJ150D20-1B serial number 8495K11094. Minimal or no subjective/aesthetic value for this component. Useful life is based primarily on normal expectations for service/performance life in this location. Unless otherwise noted remaining useful life expectancy is based primarily on original installation or last replacement/purchase date our experience with similar systems/components and assuming normal amount of usage and good preventive maintenance. We recommend that routine repairs and maintenance such as filter replacements system flushing etc. be budgeted as an Operating expense. Useful life can often be extended with proactive service and maintenance. Unless otherwise noted funding for system with same size/capacity as the current system. For split systems we recommend budgeting to replace the entire system (condensing unit and air handler) together in order to obtain better unit pricing and ensure maximum efficiency refrigerant compatibility etc. If additional costs are expected during replacement such as for system reconfiguration or expansion ductwork repairs electrical work etc. costs should be re-evaluated and adjusted as needed during future Reserve Study updates.

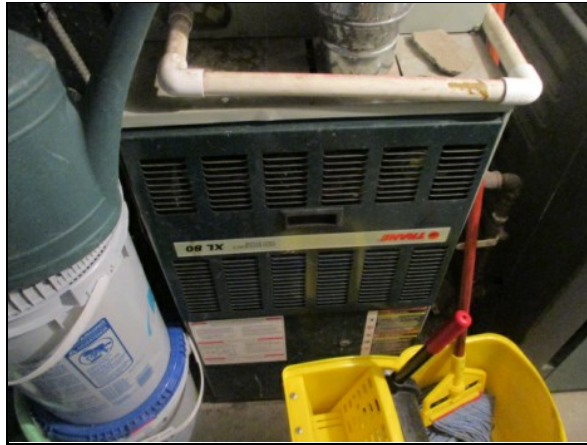
**Comp #: 25180 Furnace - Replace (Trane)**

**Comments:** Trane XL80 TUD100R948J1 serial R433JPO1G. Minimal or no subjective/aesthetic value for this component. Useful life is based primarily on normal expectations for service/performance life in this location. Unless otherwise noted remaining useful life expectancy is based primarily on original installation or last replacement/purchase date our experience with similar systems/components and assuming normal amount of usage and good preventive maintenance. We recommend that routine repairs and maintenance such as filter replacements system flushing etc. be budgeted as an Operating expense. Useful life can often be extended with proactive service and maintenance. Unless otherwise noted funding for system with same size/capacity as the current system. For split systems we recommend budgeting to replace the entire system (condensing unit and air handler) together in order to obtain better unit pricing and ensure maximum efficiency refrigerant compatibility etc. If additional costs are expected during replacement such as for system reconfiguration or expansion ductwork repairs electrical work etc. costs should be re-evaluated and adjusted as needed during future Reserve Study updates.

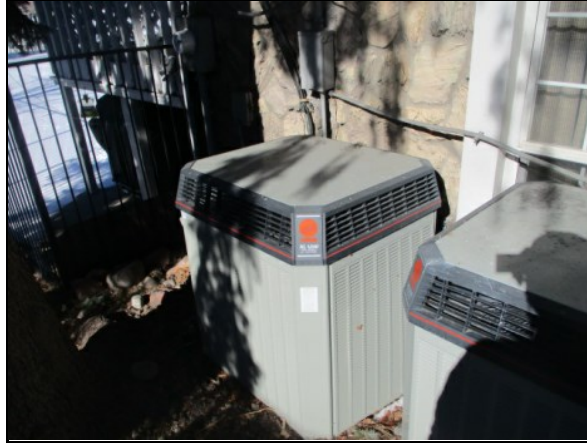
**Comp #: 25190 Condenser - Replace (4 Ton)**

**History:** Replaced in 2000

**Comments:** Trane model TXC043C4HPCO serial R453KGC5G. Minimal or no subjective/aesthetic value for this component. Useful life is based primarily on normal expectations for service/performance life in this location. Unless otherwise noted remaining useful life expectancy is based primarily on original installation or last replacement/purchase date our experience with similar systems/components and assuming normal amount of usage and good preventive maintenance. We recommend that routine repairs and maintenance such as filter replacements system flushing etc. be budgeted as an Operating expense. Useful life can often be extended with proactive service and maintenance. Unless otherwise noted funding for system with same size/capacity as the current system. For split systems we recommend budgeting to replace the entire system (condensing unit and air handler) together in order to obtain better unit pricing and ensure maximum efficiency refrigerant compatibility etc. If additional costs are expected during replacement such as for system reconfiguration or expansion ductwork repairs electrical work etc. costs should be re-evaluated and adjusted as needed during future Reserve Study updates.

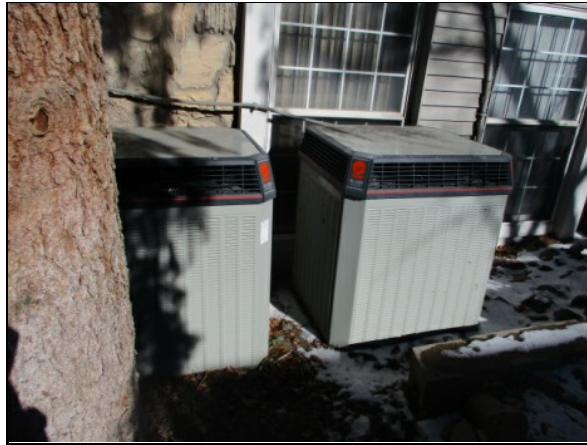
**Comp #: 25190 Condenser - Replace (5 Ton)**

**History:** Replaced in 2000

**Comments:** Trane model TXC050C4HPCO serial R451PEF5G. Minimal or no subjective/aesthetic value for this component. Useful life is based primarily on normal expectations for service/performance life in this location. Unless otherwise noted remaining useful life expectancy is based primarily on original installation or last replacement/purchase date our experience with similar systems/components and assuming normal amount of usage and good preventive maintenance. We recommend that routine repairs and maintenance such as filter replacements system flushing etc. be budgeted as an Operating expense. Useful life can often be extended with proactive service and maintenance. Unless otherwise noted funding for system with same size/capacity as the current system. For split systems we recommend budgeting to replace the entire system (condensing unit and air handler) together in order to obtain better unit pricing and ensure maximum efficiency refrigerant compatibility etc. If additional costs are expected during replacement such as for system reconfiguration or expansion ductwork repairs electrical work etc. costs should be re-evaluated and adjusted as needed during future Reserve Study updates.

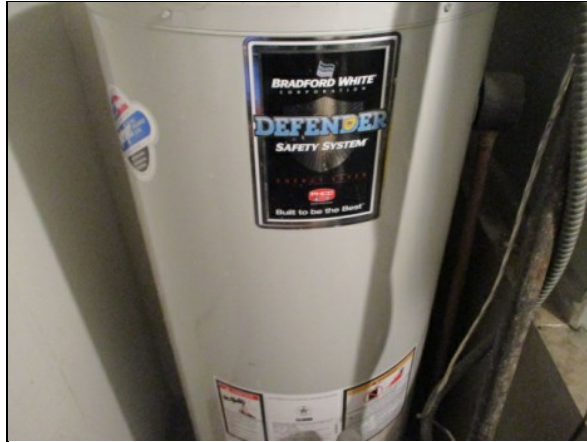
**Comp #: 25460 Water Heater/Tank - Replace**

**Comments:** Bradford White M:RG240T6N, S:XD47715975. Minimal or no subjective/aesthetic value for this component. Useful life is based primarily on normal expectations for service/performance life in this location. Unless otherwise noted remaining useful life expectancy is based primarily on original installation or last replacement/purchase date our experience with similar systems/components and assuming normal amount of usage and good preventive maintenance. Water heater life expectancies can vary greatly depending on level of use type of technology amount of preventive maintenance and other factors. Should be inspected and repaired as needed by servicing vendor or maintenance staff. Unless otherwise noted expected to be functional. Plan to replace at the approximate interval shown below. When evaluating replacements we recommend choosing high-efficiency or tankless models if possible in order to minimize energy usage.

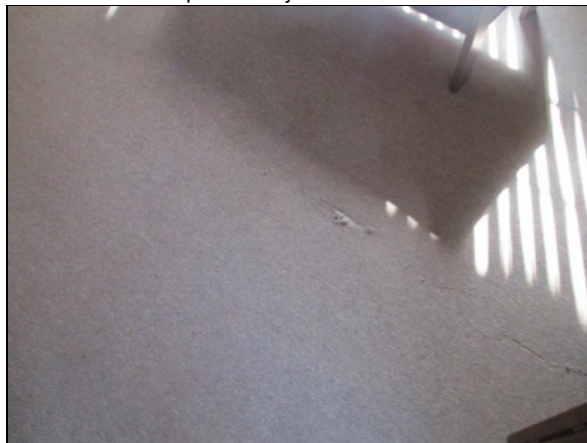
**Comp #: 27130 Clubhouse Carpet - Replace**

**Comments:** Carpeted surfaces were determined to be in poor condition. Evidence of staining matting and loose seams noted. Expect the need to replace the carpeting soon based upon the aesthetics of the building. As part of ongoing maintenance program vacuum regularly and professionally clean as needed. Best practice is to coordinate at same time as other interior projects whenever possible to minimize downtime and maintain consistent quality standard. Timing and interval is somewhat subjective but not as flexible as other flooring finishes (tile wood etc.). Estimates shown here are based on our experience with similar properties and general aesthetic qualities. Schedule can be updated/adjusted at the discretion of the association for planning purposes.

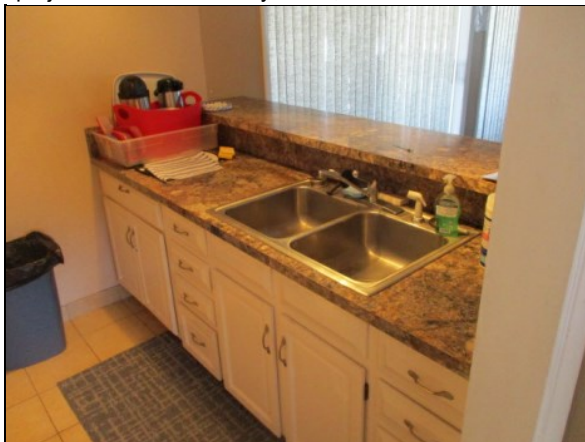
**Comments:** Includes 10 LF of base cabinets, 8 LF of wall cabinets, 30 GSF, of laminate counters (1) sink. Kitchen was observed to be in fair condition. Counters and cabinets were clean and mostly free of issues. Fixtures appeared to be in fair condition. Kitchen materials typically have an extended useful life. However, many clients choose to refurbish the kitchen periodically for aesthetic updating. This may include refurbishment/refinishing of kitchen cabinets and countertops, replacement of sinks, installation/replacement of under-cabinet lighting, etc. Should ideally be coordinated with replacement of the kitchen appliances. Best practice is to coordinate this project with other amenity areas, such as bathrooms or other amenity rooms.

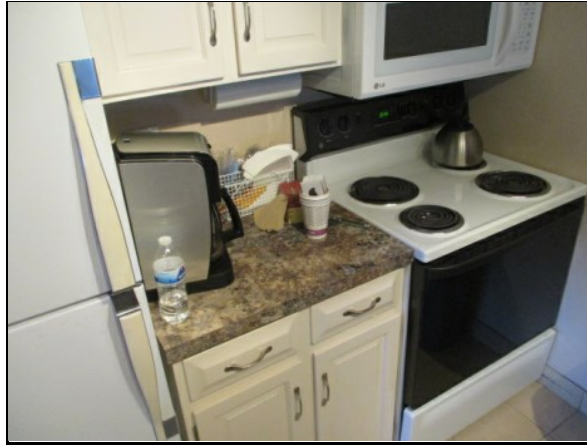
**Comp #: 27320 Kitchen Appliances - Replace**

**Comments:** Individual appliances were not tested during inspection and are assumed to be in functional operating condition unless otherwise noted. Useful life can vary greatly depending on level of use quality care and maintenance etc. Funding recommendation shown here is for replacing with comparable quality commercial-grade appliances.

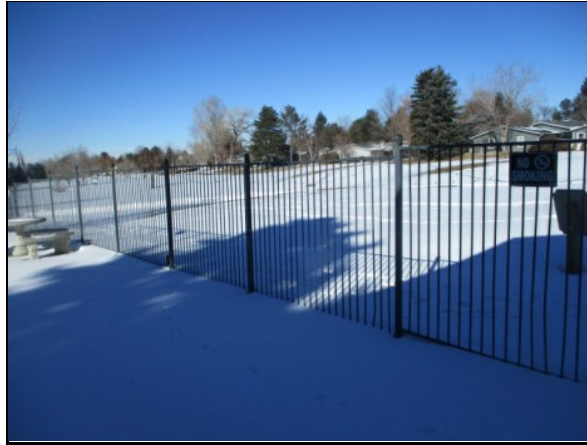
**Comp #: 28030 Pool Fence - Replace**

**Comments:** Based on reported age client should be prepared to replace soon.
